Torpedo Plant Dock and Piers:

Technical Analysis and Design Recommendations

City of Alexandria, Virginia

July, 1979

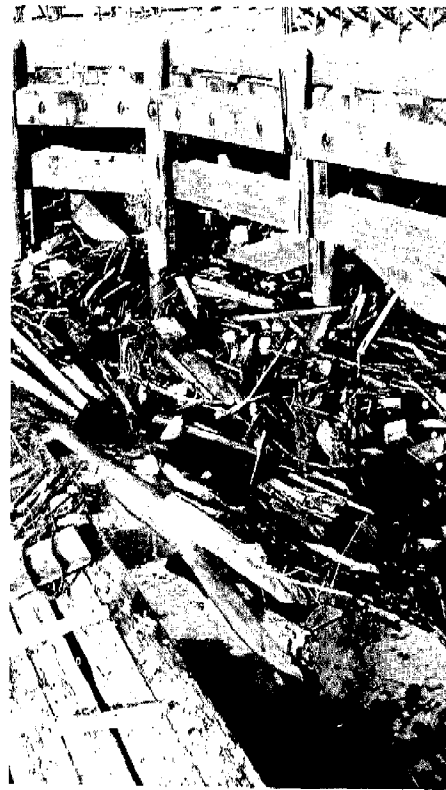
Figure 43 Debris collects at base of dock

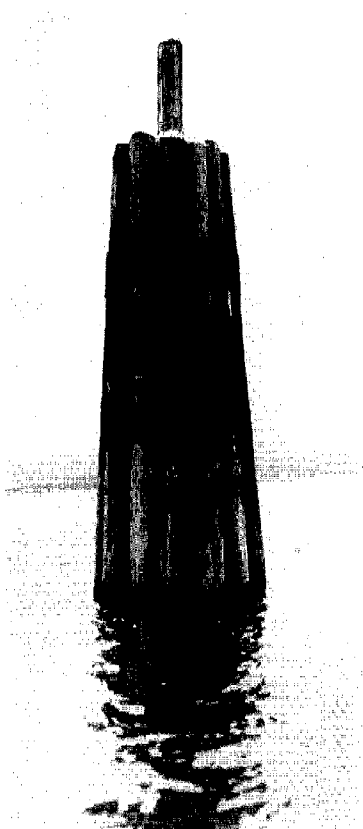
Figure 44 Dolphin No. N-1

- **Dolphins are in good condition.**

- Piles in dolphins were sample tested and are considered in satisfactory condition.

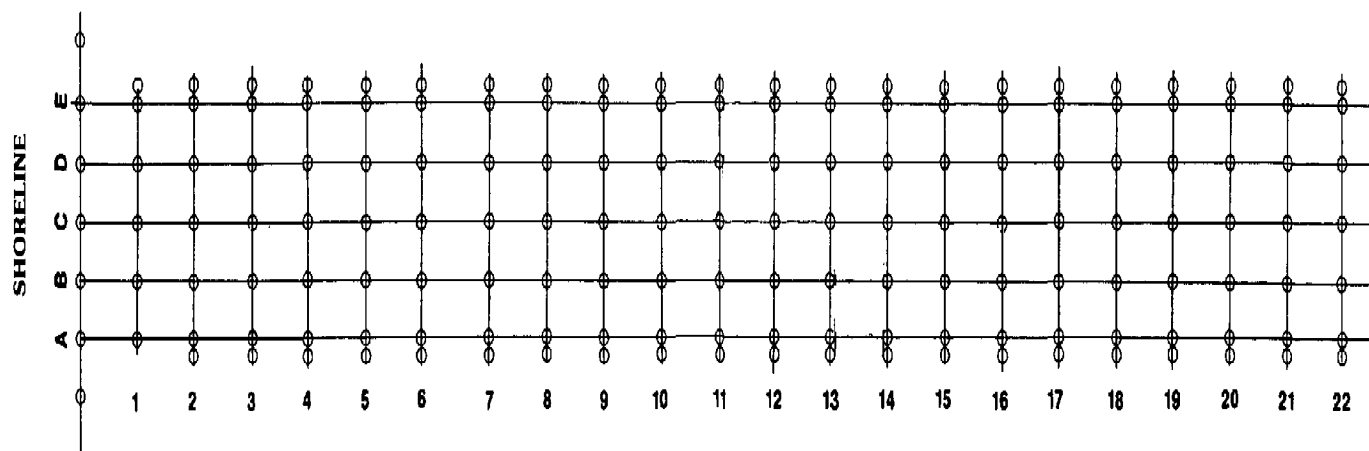
Figure 48 Piling Plan
of South Pier

Location No. 6 Column A,C-appear sound Column B,D,E-decayed x-Brace-all decayed	Location No. 10 Column B,E-decayed Column C-poor treatment Column D-appears sound Plates-contain some decay	Location No. 14 Column A,B,D-appear sound Column C,E-decayed x-Brace-all decayed Plates-appear sound
